Debris/Ice/TPS Assessment and Integrated Photographic Analysis of Shuttle Mission STS-95

**DEBRIS/ICE/TPS ASSESSMENT
AND
INTEGRATED PHOTOGRAPHIC ANALYSIS
OF
SHUTTLE MISSION STS-95**

29 October 1998

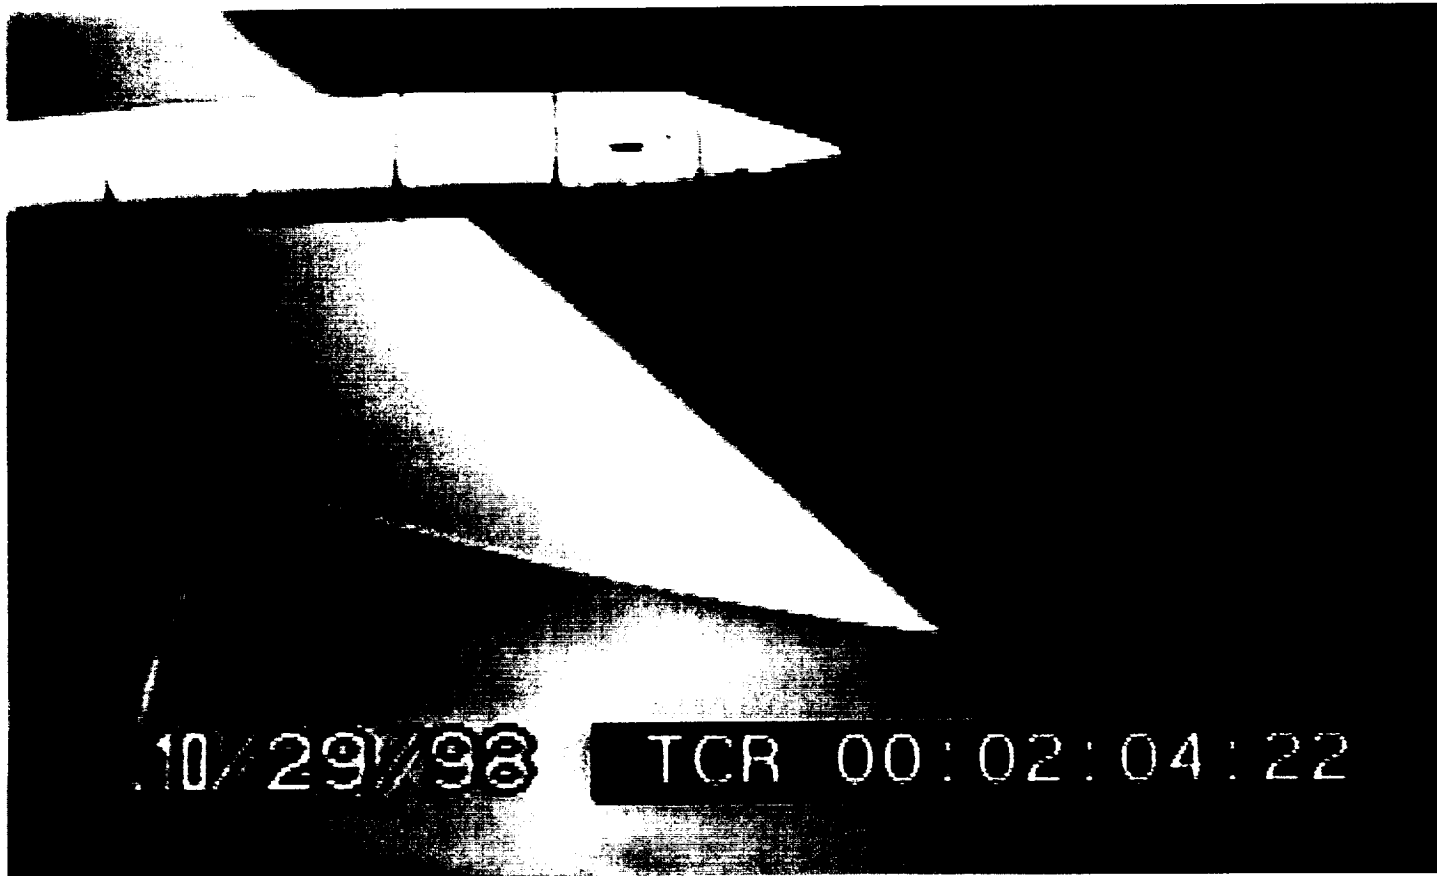
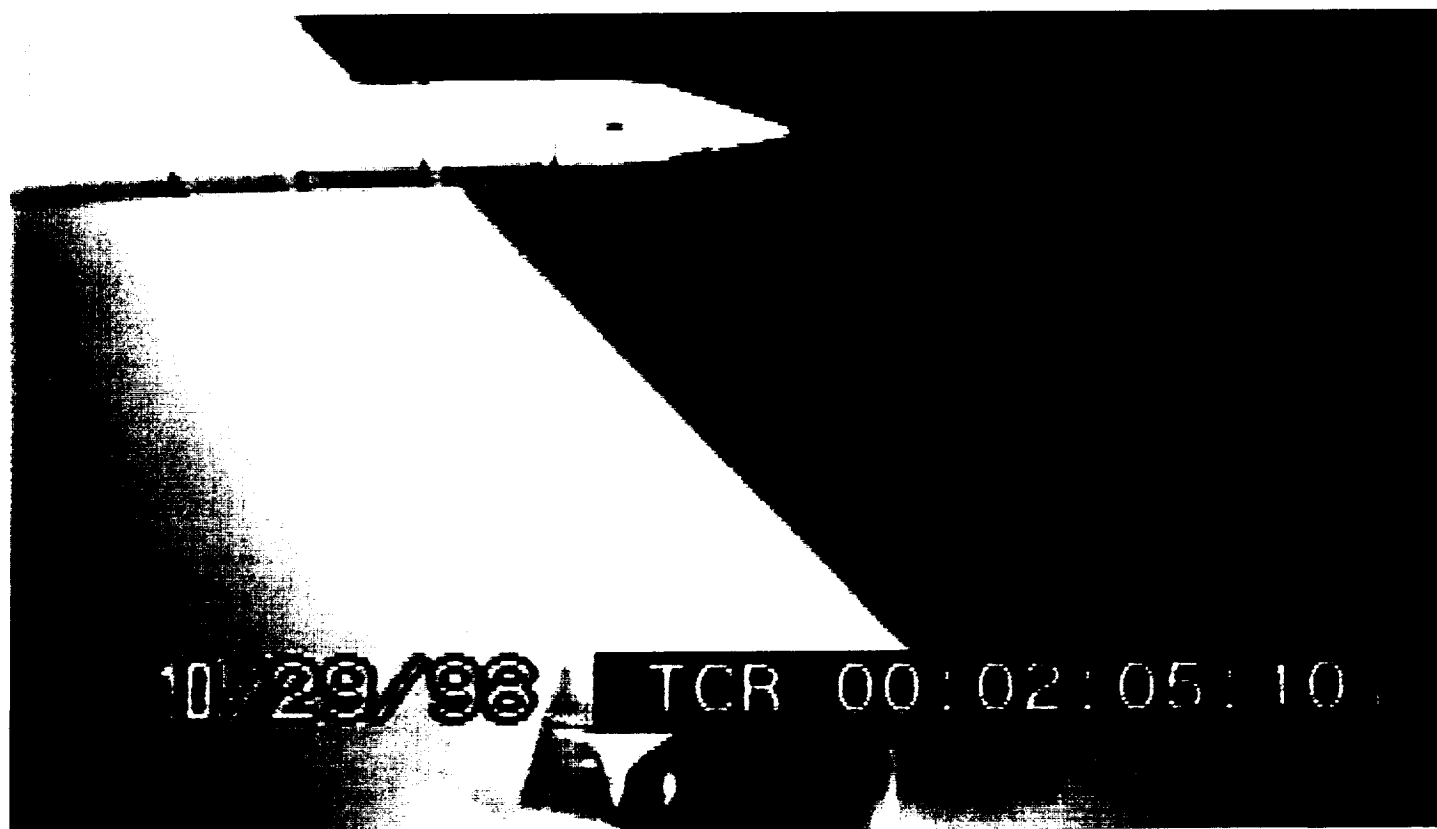
Photo 19: SRB Separation from External Tank

TPS on ET third hard point and aft dome is in good condition.
Orbiter elevons and a portion of the body flap are visible to the left of the ET aft dome.

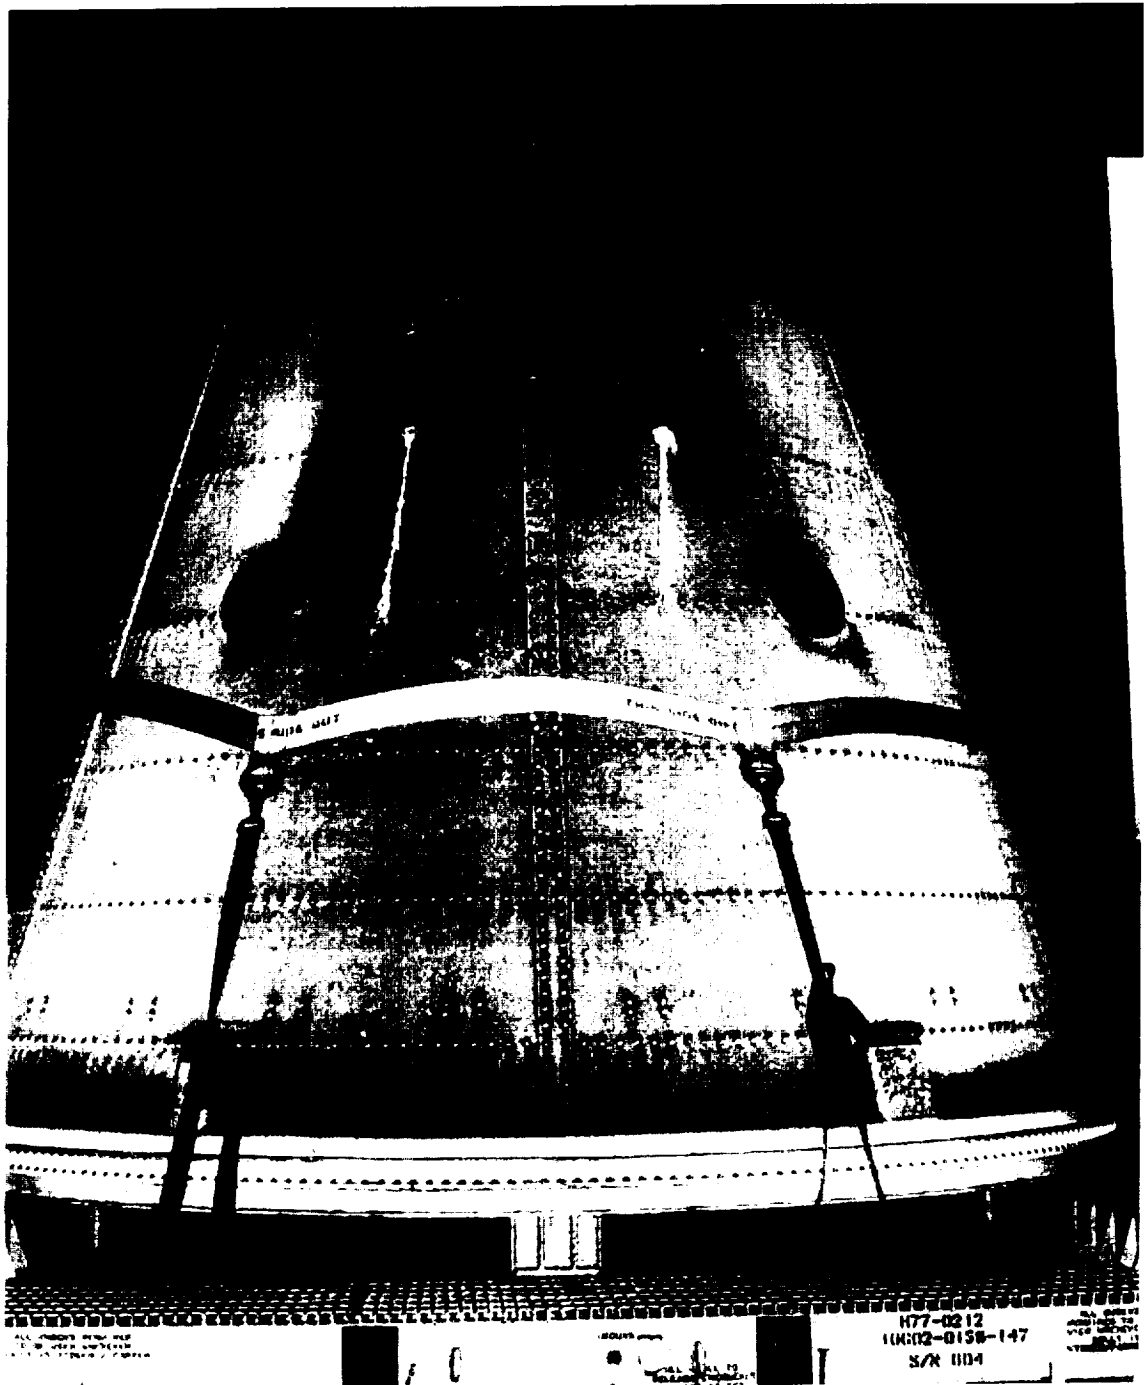
Photo 28: Frustum Post Flight Condition

Both frustums were in excellent condition. No TPS was missing and no debonds/unbonds were detected over fasteners or acreage. Virtually none of the Hypalon paint had blistered or peeled. All eight BSM aero heat shield covers had locked in the fully opened position though the attach rings on the two outboard covers on the left frustum had been bent by parachute riser entanglement.

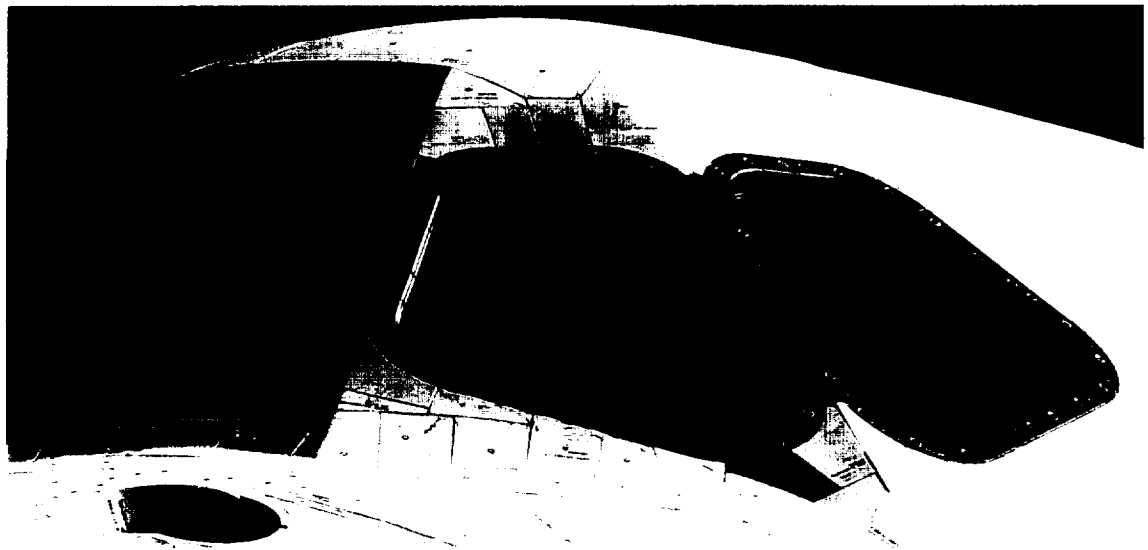
Photo 34: Windows

Hazing and streaking of forward-facing Orbiter windows was moderate to heavy. Damage sites on the window perimeter tiles was less than usual in quantity and size. Some of the damage sites were attributed to old repair material falling out and were not included in this assessment.

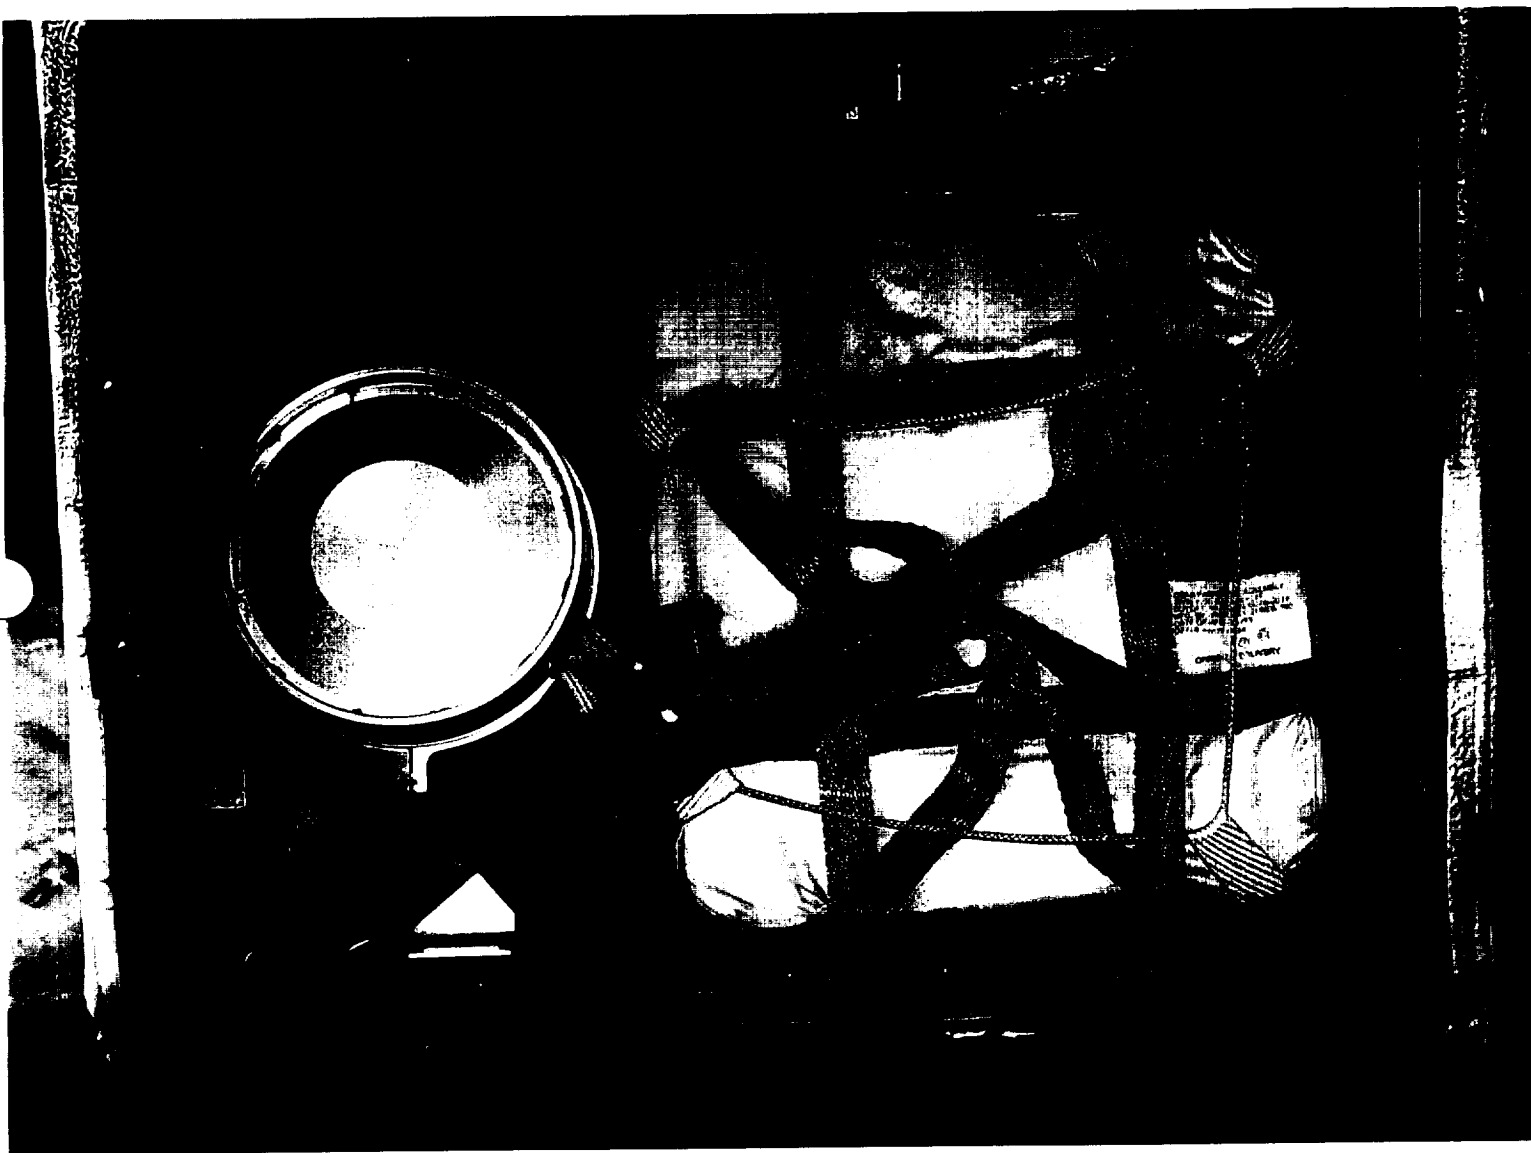
Photo 36: Drag Chute Compartment

After losing the drag chute door at liftoff, the drag chute was exposed to ascent, on-orbit, and re-entry environments. Close examination after landing determined the drag chute was intact and the nylon restraining straps barely discolored. There was no damage to the pyrotechnic devices or firing lines. Also note no apparent damage to the drag chute door hinges or shear pin flanges.

Subsequent attempts to duplicate the door failure in the laboratory were not entirely successful leaving the Investigation Board to conclude an unexplained anomaly possibly associated with the environment - an acoustic vibration or overpressure wave that exceeded the design parameters of the door. The pad and MLP for the next few launches will be instrumented to gather data on the SSME startup environment. In addition, the drag chute door design is being modified and will incorporate greater material margins. Until that effort is complete, the drag chute door will be bolted to the Orbiter structure and landings will be made without using the chute.

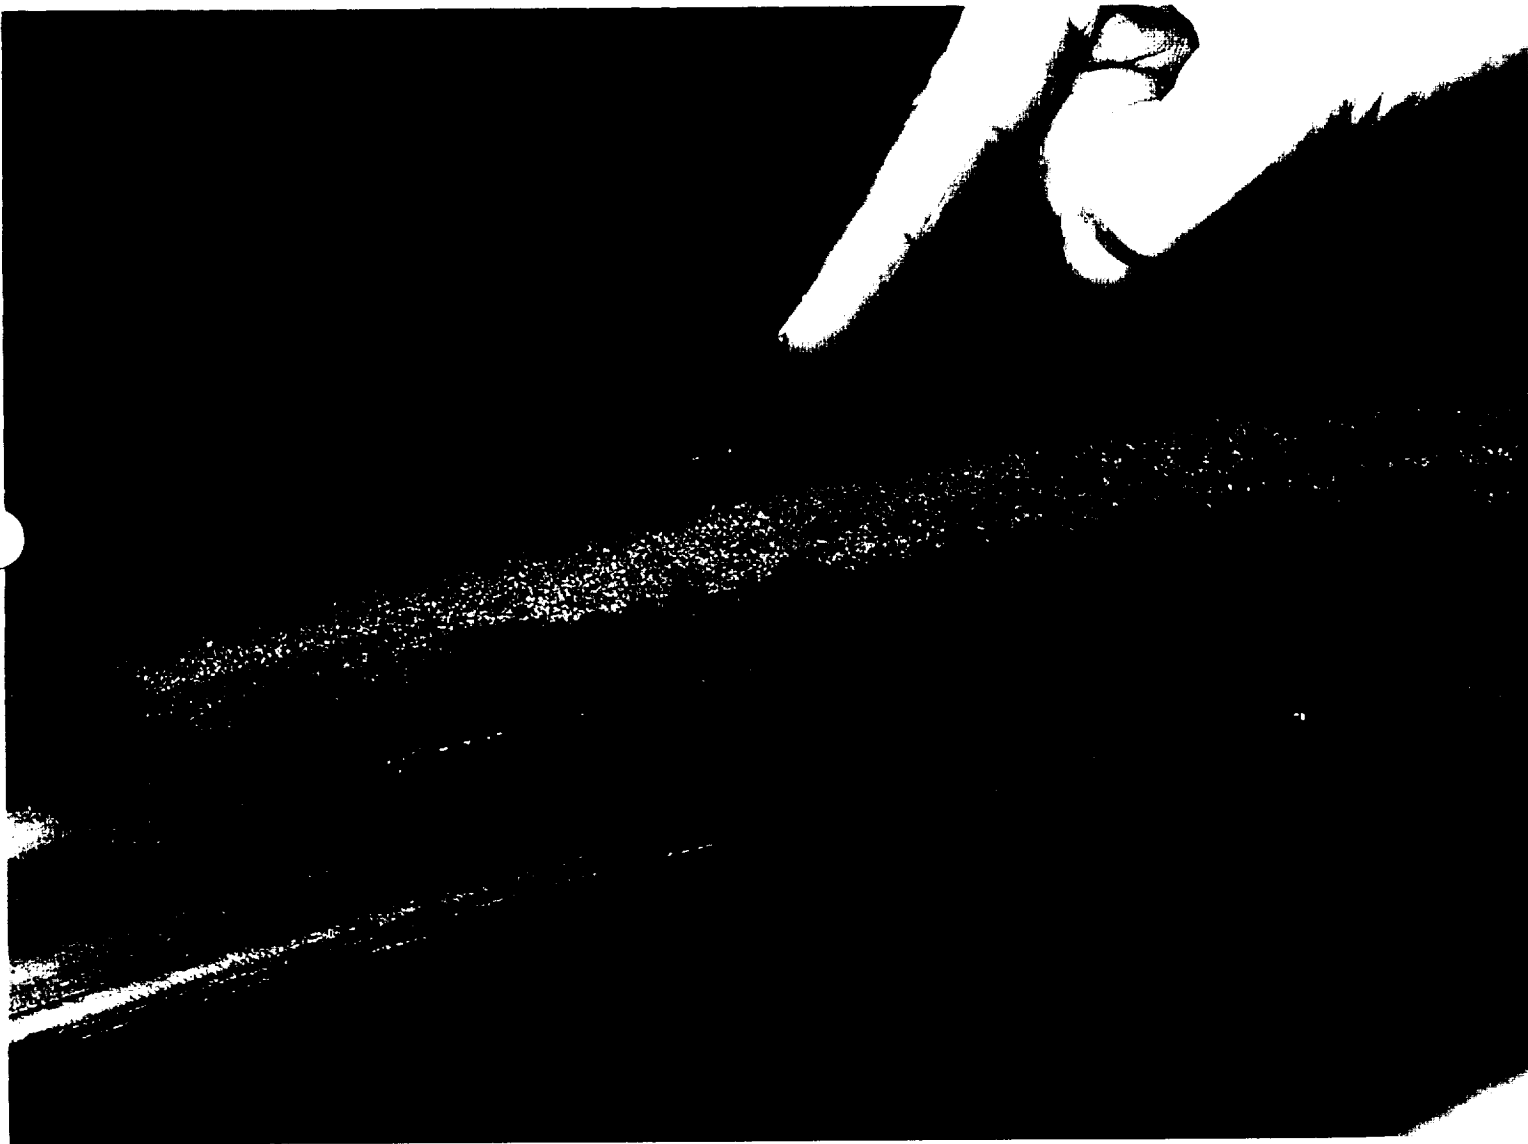
Photo 37: SSME #1 Aft Manifold

Point of impact by the drag chute door at liftoff. The impact occurred on the aft manifold and did not damage the engine nozzle or any of the high pressure hydrogen tubes.
